UNITED STATES
DEPARTMENT OF THE INTERIOR
BUREAU OF MINES

Welch, West Virginia
February 12, 1959

Subject: Report on investigation of miner coal outburst (bump), Mary Helen No. 3 mine, Mary Helen Coal Corporation, Coalgood, Harlan County, Kentucky

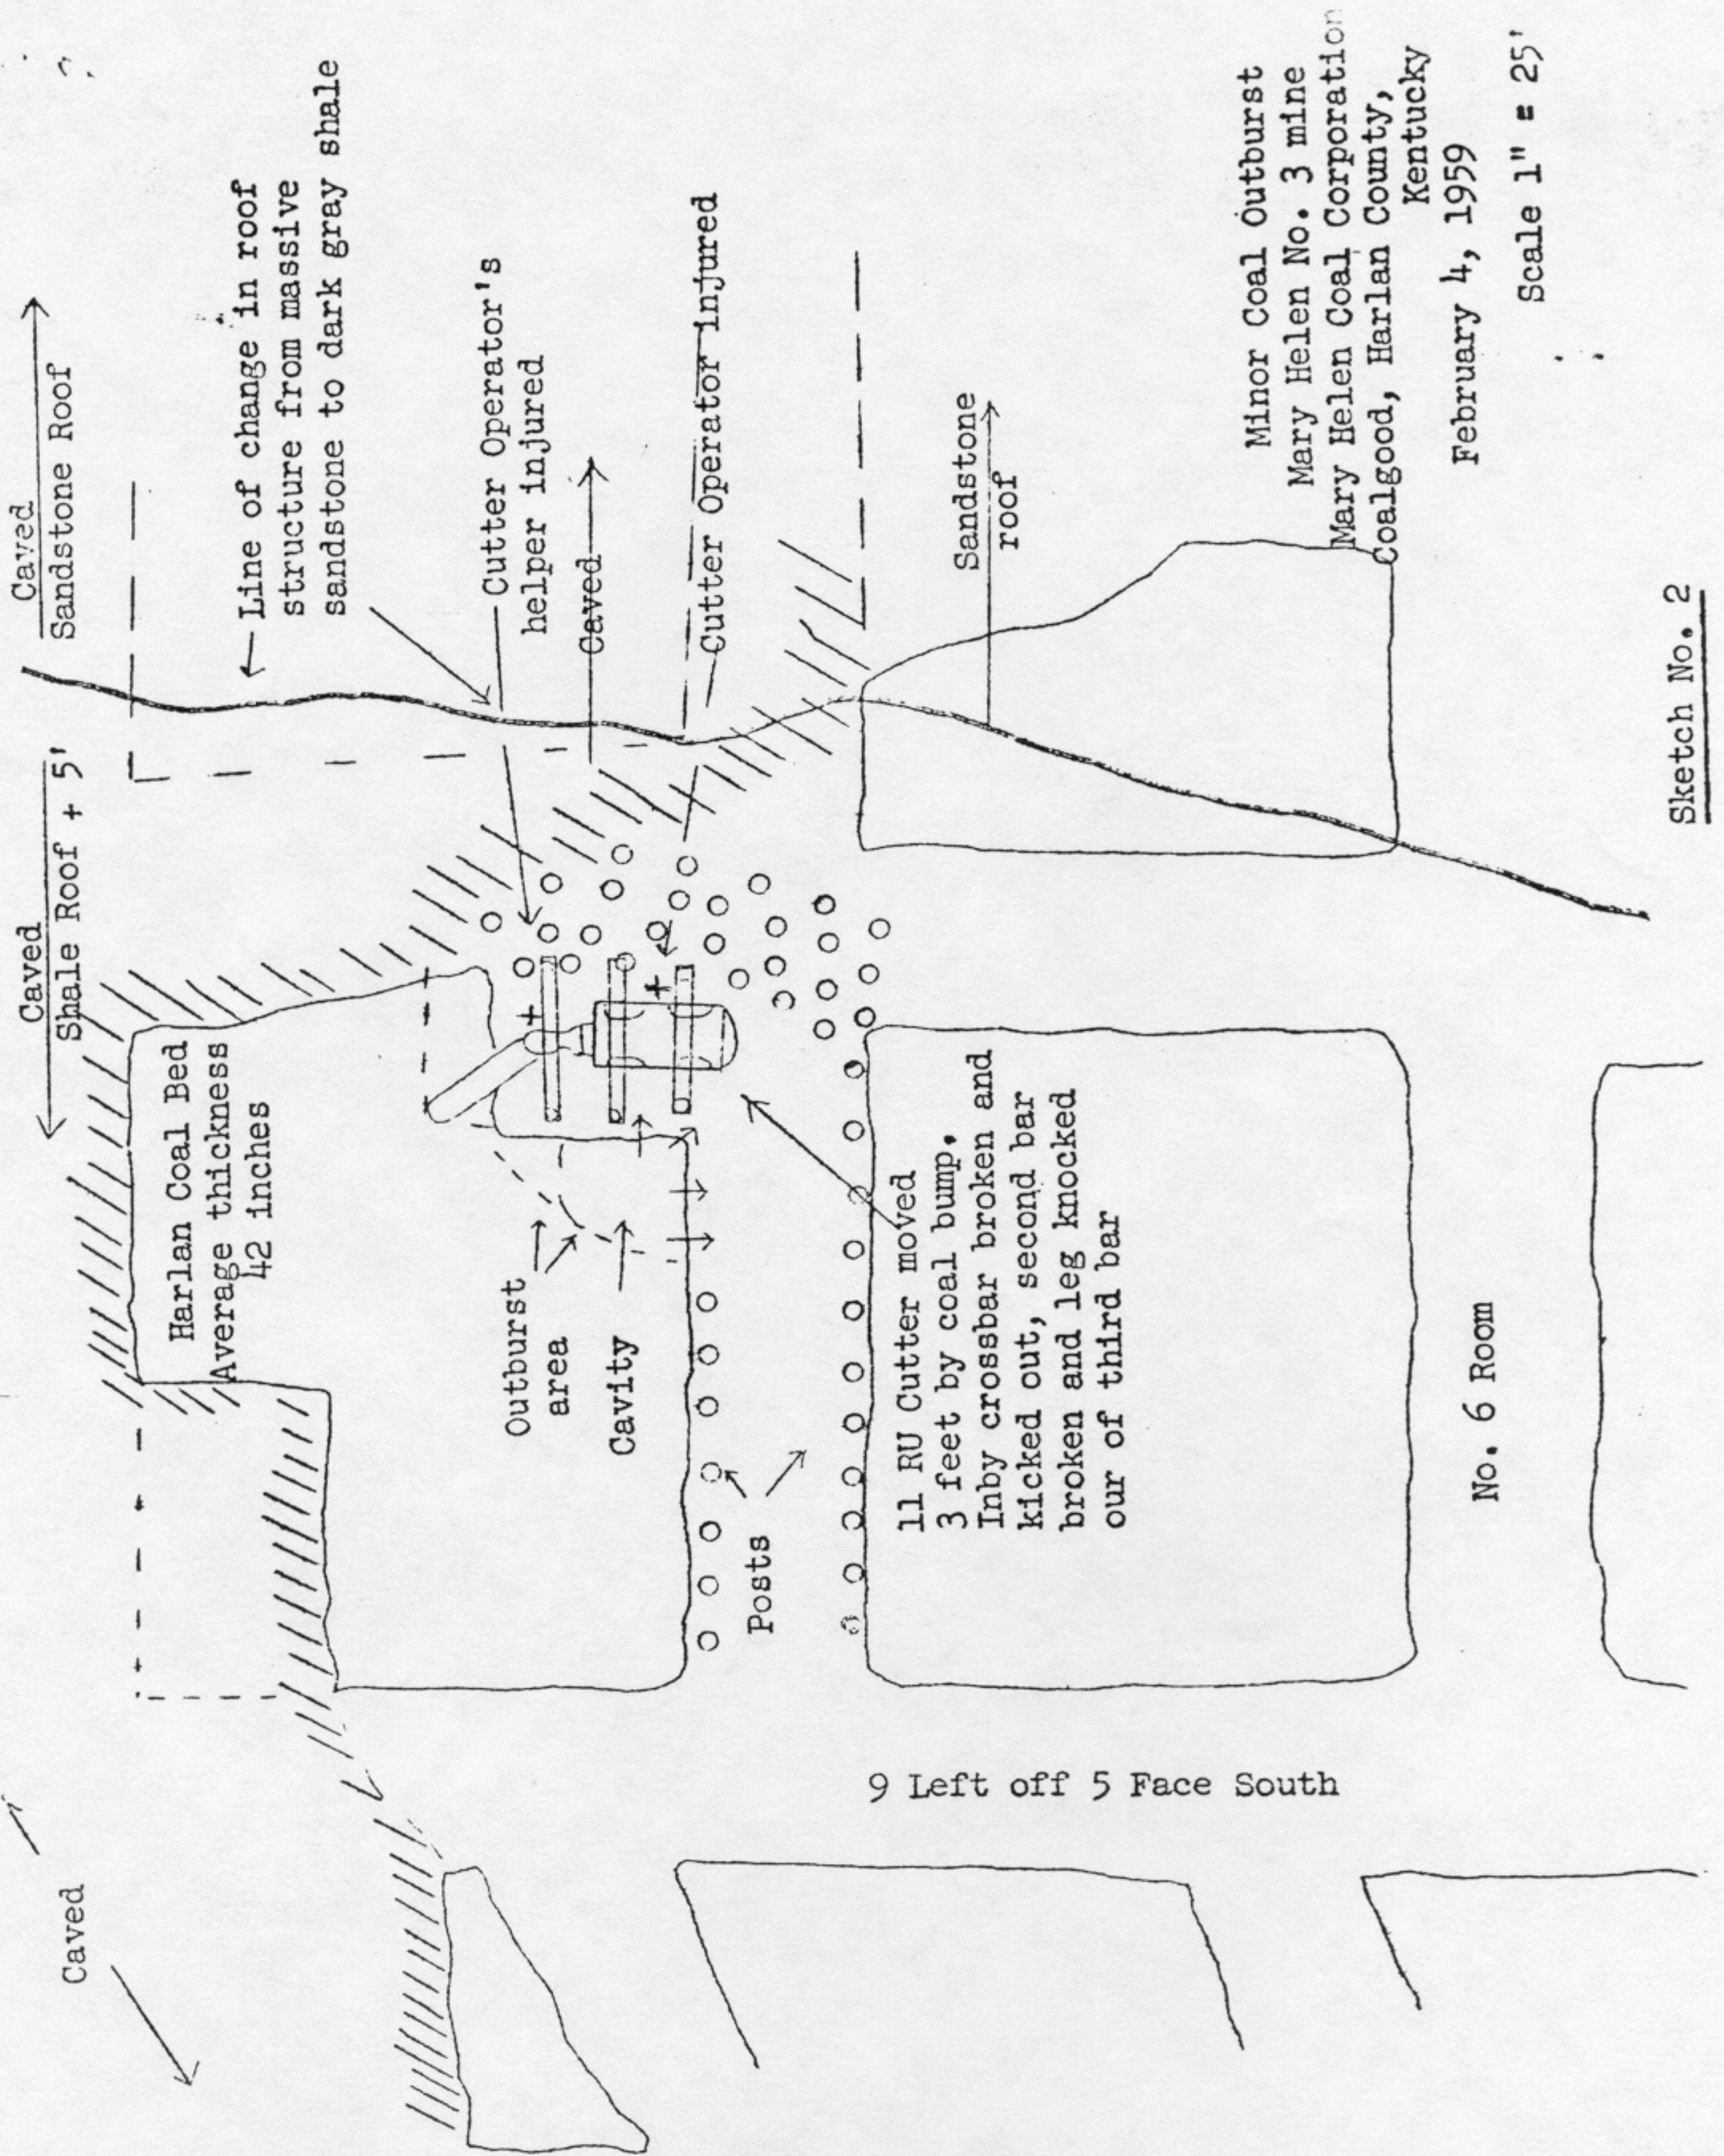
The outburst occurred while the cutting-machine crew was under-cutting an open-end lift (pocket) with an 11 RU Joy cutting machine (permissible type) in the first pillar block (the last remaining pillar) in No. 7 room on 9 left off 5 face south. (See Sketch No. 1). The pillar lift was the first lift to be turned into this block from the room side, and it was 16 to 18 feet in width and 20 feet in depth; however, from sketch No. 2 it will be noted that a similar open-end lift is projected a distance of 30 feet into the block (next to the gob) from the 9 left entry, but this pillar lift was abandoned after development of a bad roof condition and subsequent collapse of the roof at the entrance to the lift. This condition led to the decision to turn the alternate open-end lift from the No. 7 room side of the block and complete extraction of the block from this side. The pillar being worked was the only one affected by the outburst.

It will be noted that from Sketch No. 1 that the 9 left pillars were in fair alignment with the corresponding pillars in the 8 left panel, notwithstanding the fact that the 9 left section was about 2 months later getting started than 8 left, and 3 months later than 10 and 11 lefts. Because of the adverse conditions in 9 left, concerted effort was made to bring the 9 left line of extraction abreast as rapidly as feasible so as to maintain a relatively flat pillar line.

It is well to point out that the 9 left entry and air course and the first pillar in each of the rooms in 9 left, are situated at the lowest horizon of a rather steep local indulation or basin extending from 8 left to the center of 10 left. The crest of the grade in 8 left and in 10 left is about 15 and 25 feet higher, respectively, than the 9 left areas mentioned above.

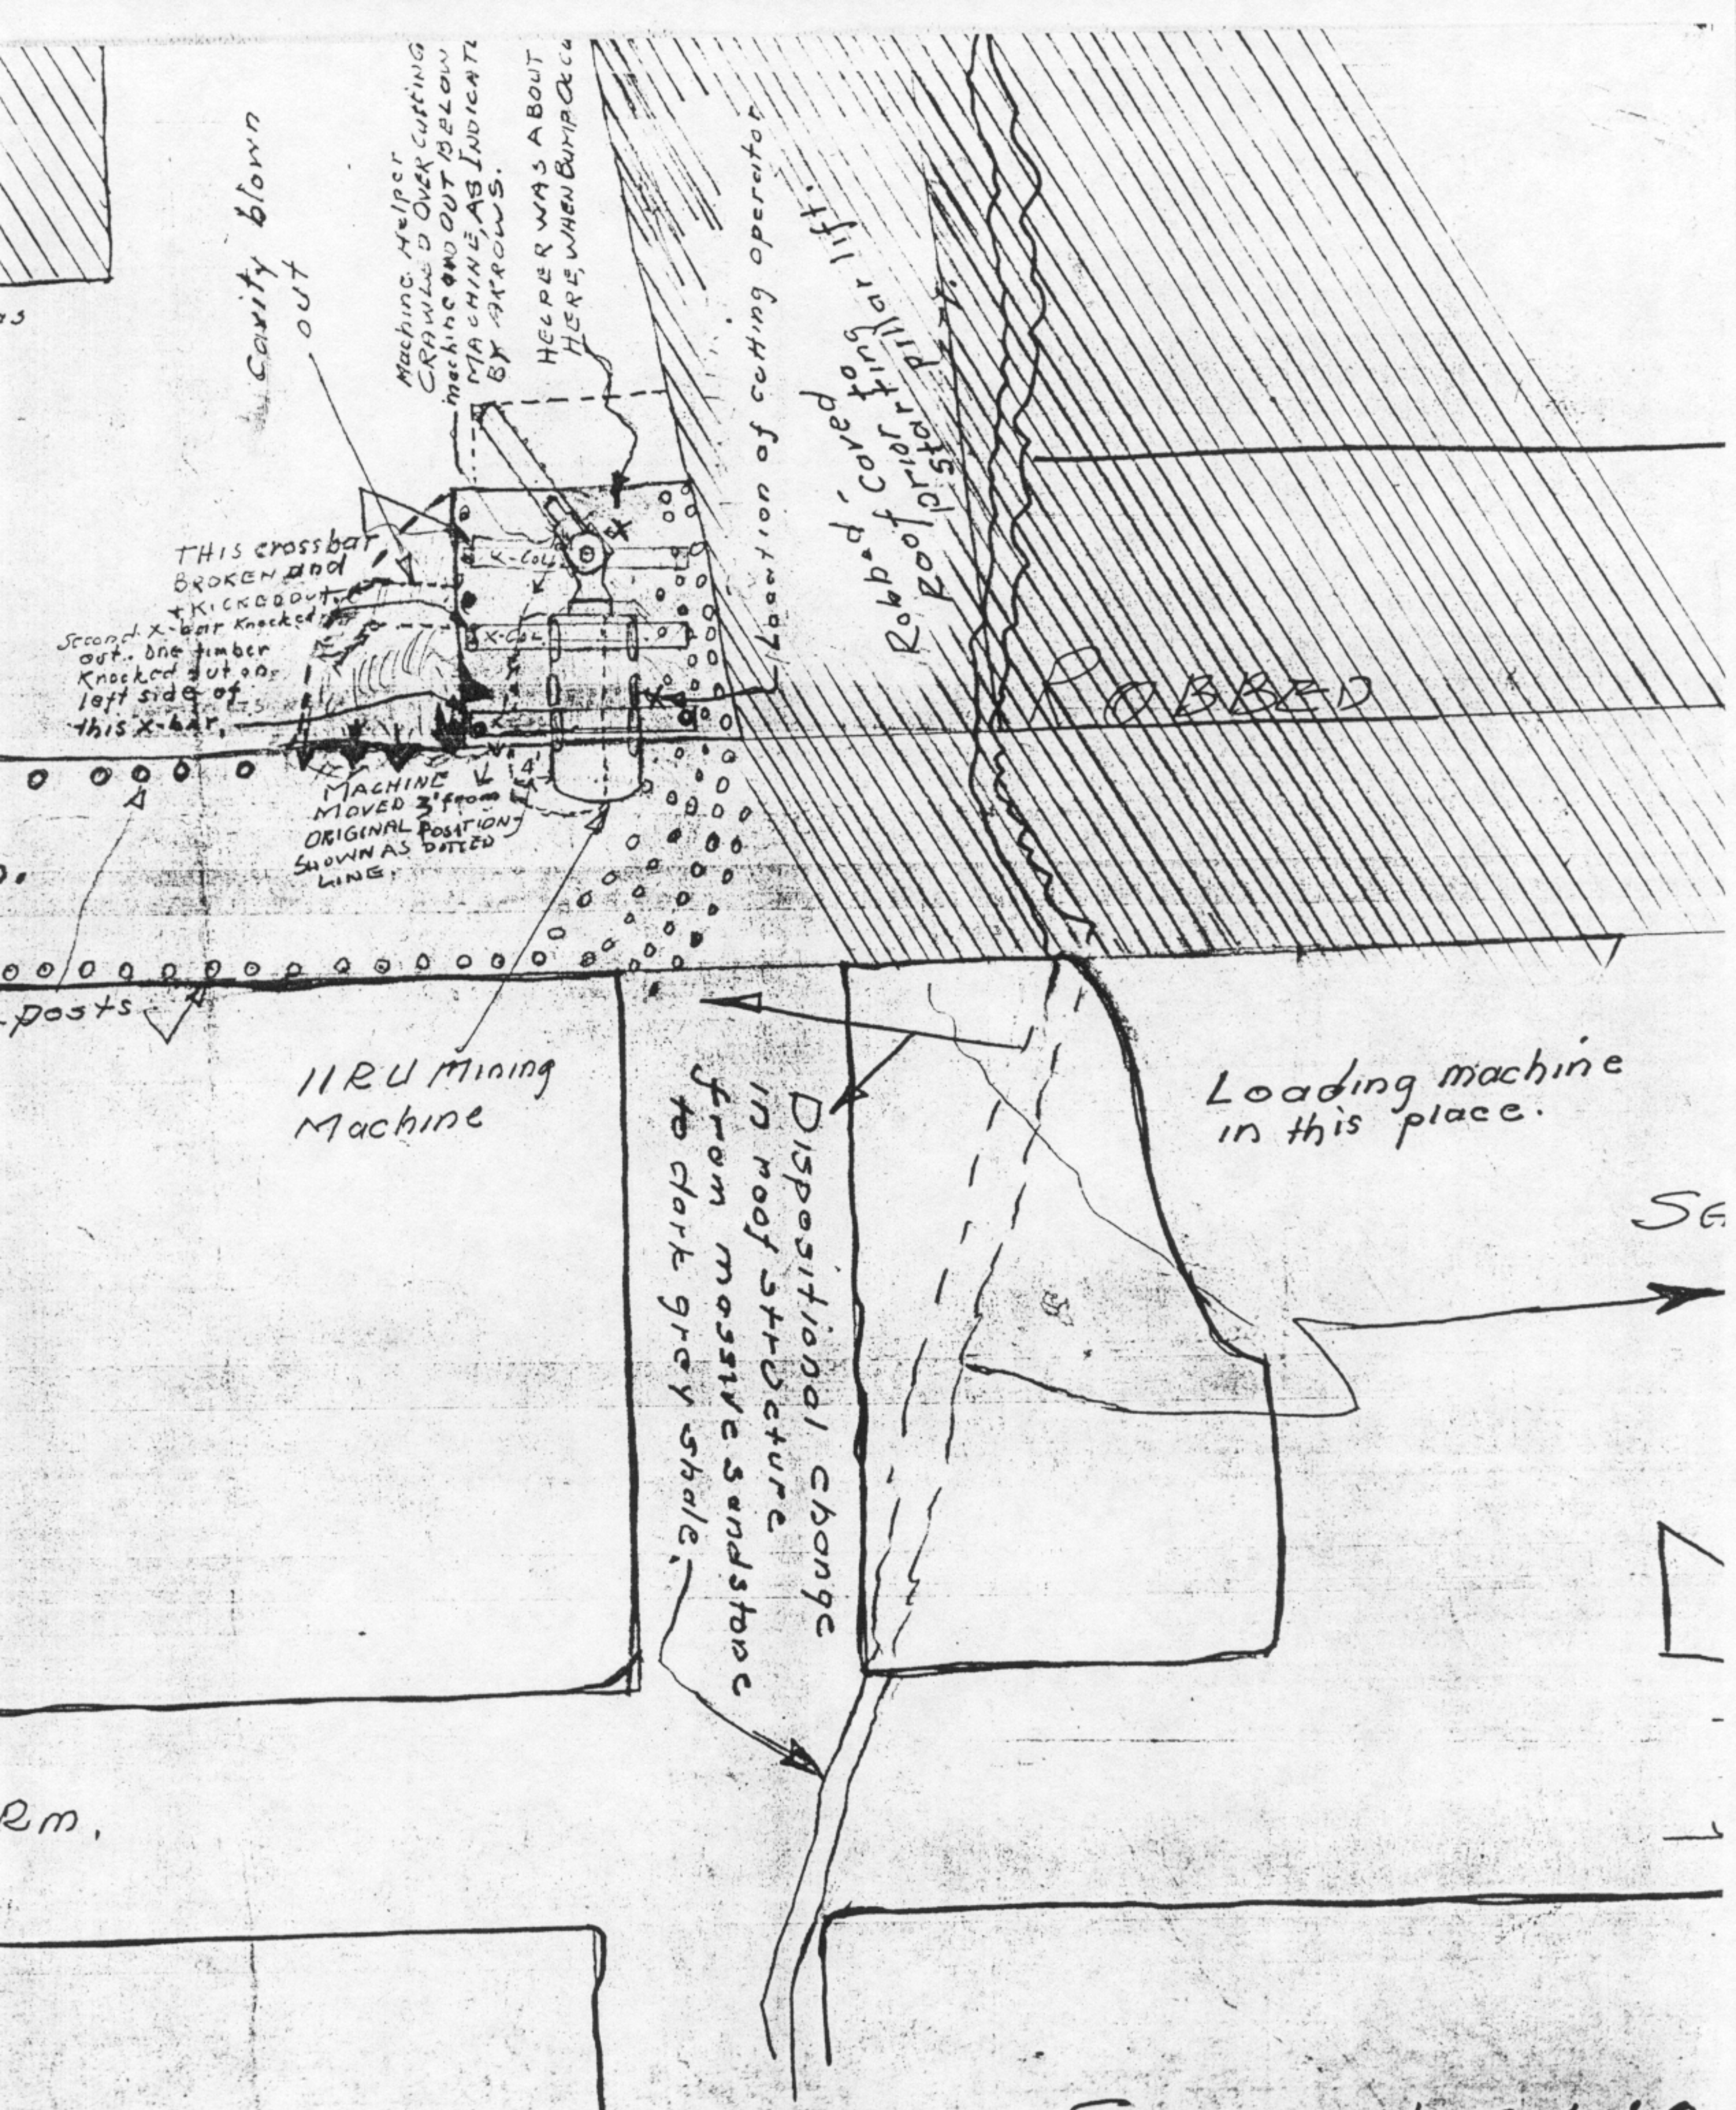
SKETCH NO. 2

At the time of the outburst, the third undercut was being made in No. 7 room pillar lift, as indicated in Sketch No. 2, and the loading machine was in the second pillar in No. 6 room, but was not operating. The cutting machine had cut about three-fourths across the face from the open-end toward the coal rib, and the cutting-machine crew were at the locations indicated in Sketch No. 2.

The reaction of the outburst forced the cutting machine sidewise (jack-knife fashion) about 3 feet and about 12 tons of coal was thrown from the coal rib but none was thrown from the face of the lift. Most of the coal it will be noted, was thrown outward from the corner of the pillar (at the entrance to the lift) and a cavity about 1-1/2 feet in diameter extended about 8 feet within the pillar. This cavity evidently was the result of the comparatively violent expulsion (outward movement) of the coal at the corner of the pillar lift. The roof in the immediate vicinity of the outburst was not shaken down or detached, but several cracks opened in the roof in the pillar lift involved and a lesser number were observed in the adjacent No. 6 room pillar. There were three crossbars in addition to posts set according to plan in the pillar lift. One crossbar was broken, one was dislodged, and a timber was knocked from under the end of the third crossbar by the outrush of coal and/or forces. Damage to the cutting machine consisted of a burst hydraulic hose, a bent boom-swing-jack piston rod, and a broken cutter-chain adjustment bolt. Reportedly, gas was not detected with a flame safety lamp and the electric power was cut off immediately after the outburst.
